Peregrine Water-Cooled High Performance Compute Cluster

LESSONS LEARNED

DAVID J. MARTINEZ
ELECTROMECHANICAL TECHNOLOGIST
RESEARCH & DEVELOPMENT
SANDIA NATIONAL LABORATORIES

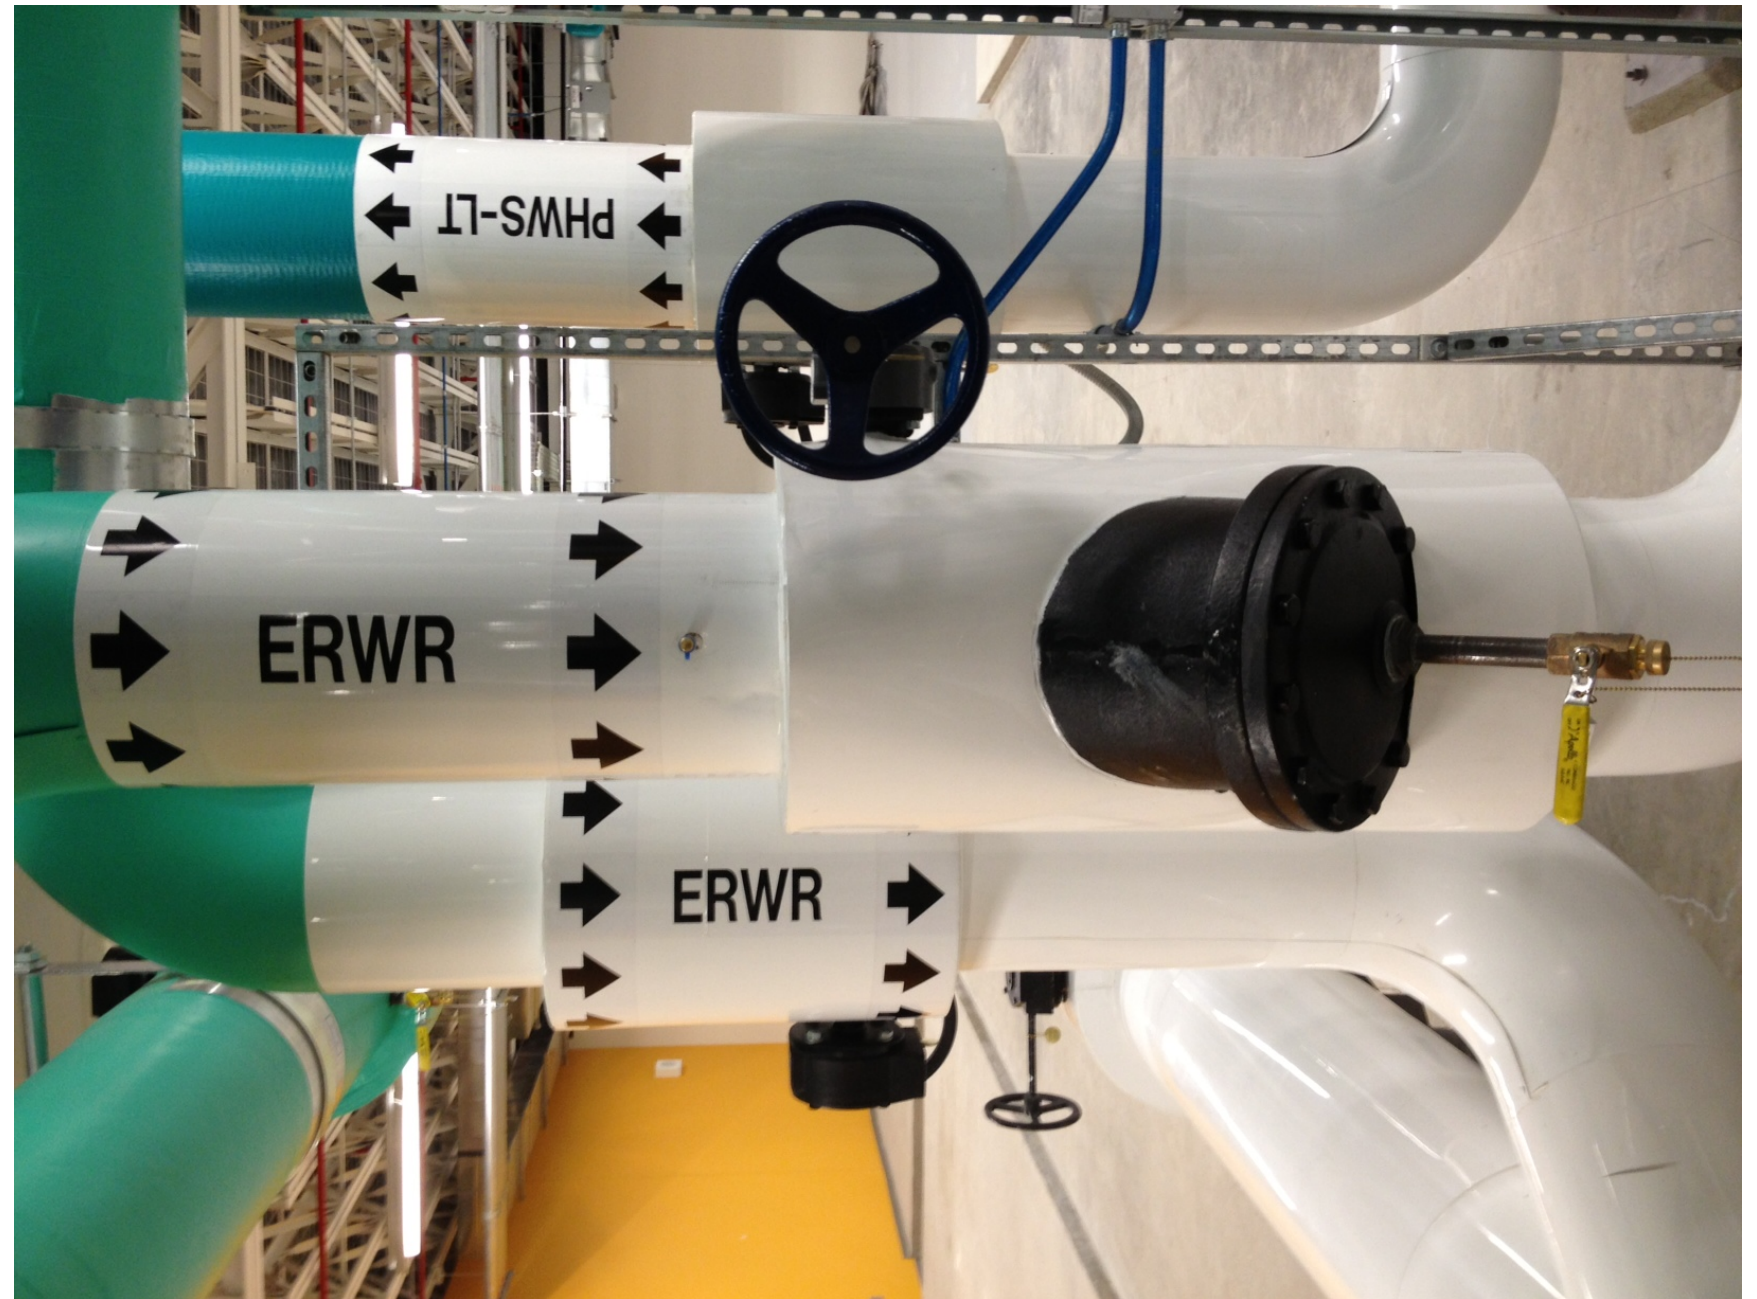
When testing the water flow/flushing noticed back pressure build up on the secondary pump and a low flow condition when sequencing in the energy recovery loop.

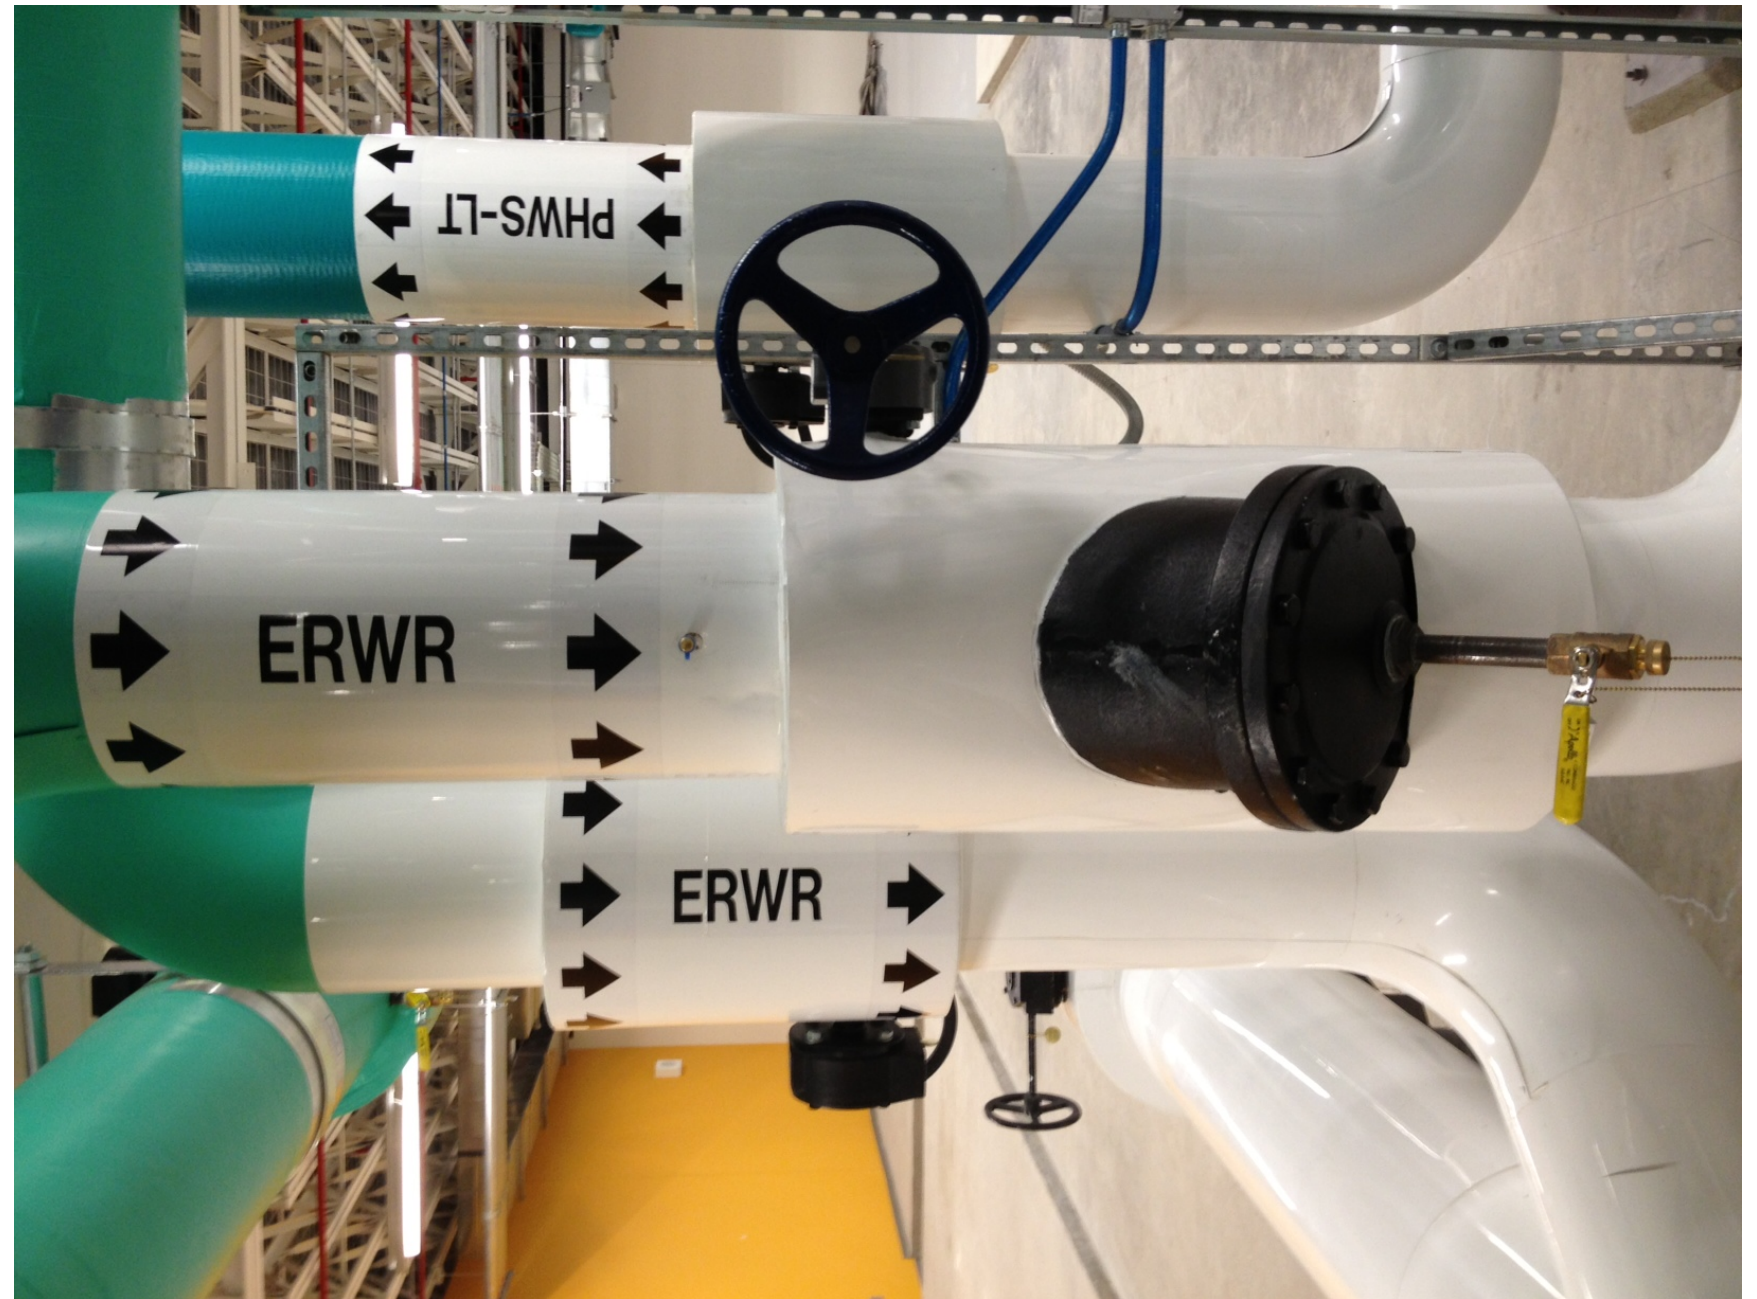
After checking the VFD for the secondary pump (to insure the proper control signal) and verified the control signal was correct proceeded to follow the piping path thru the HX.

After following the path the probable cause was isolated to 3 components: 1. the valve before the strainer (highly unlikely to fail), 2. The strainer may be dirty (most probable) and 3. The HX itself may have fouled (not very probable).

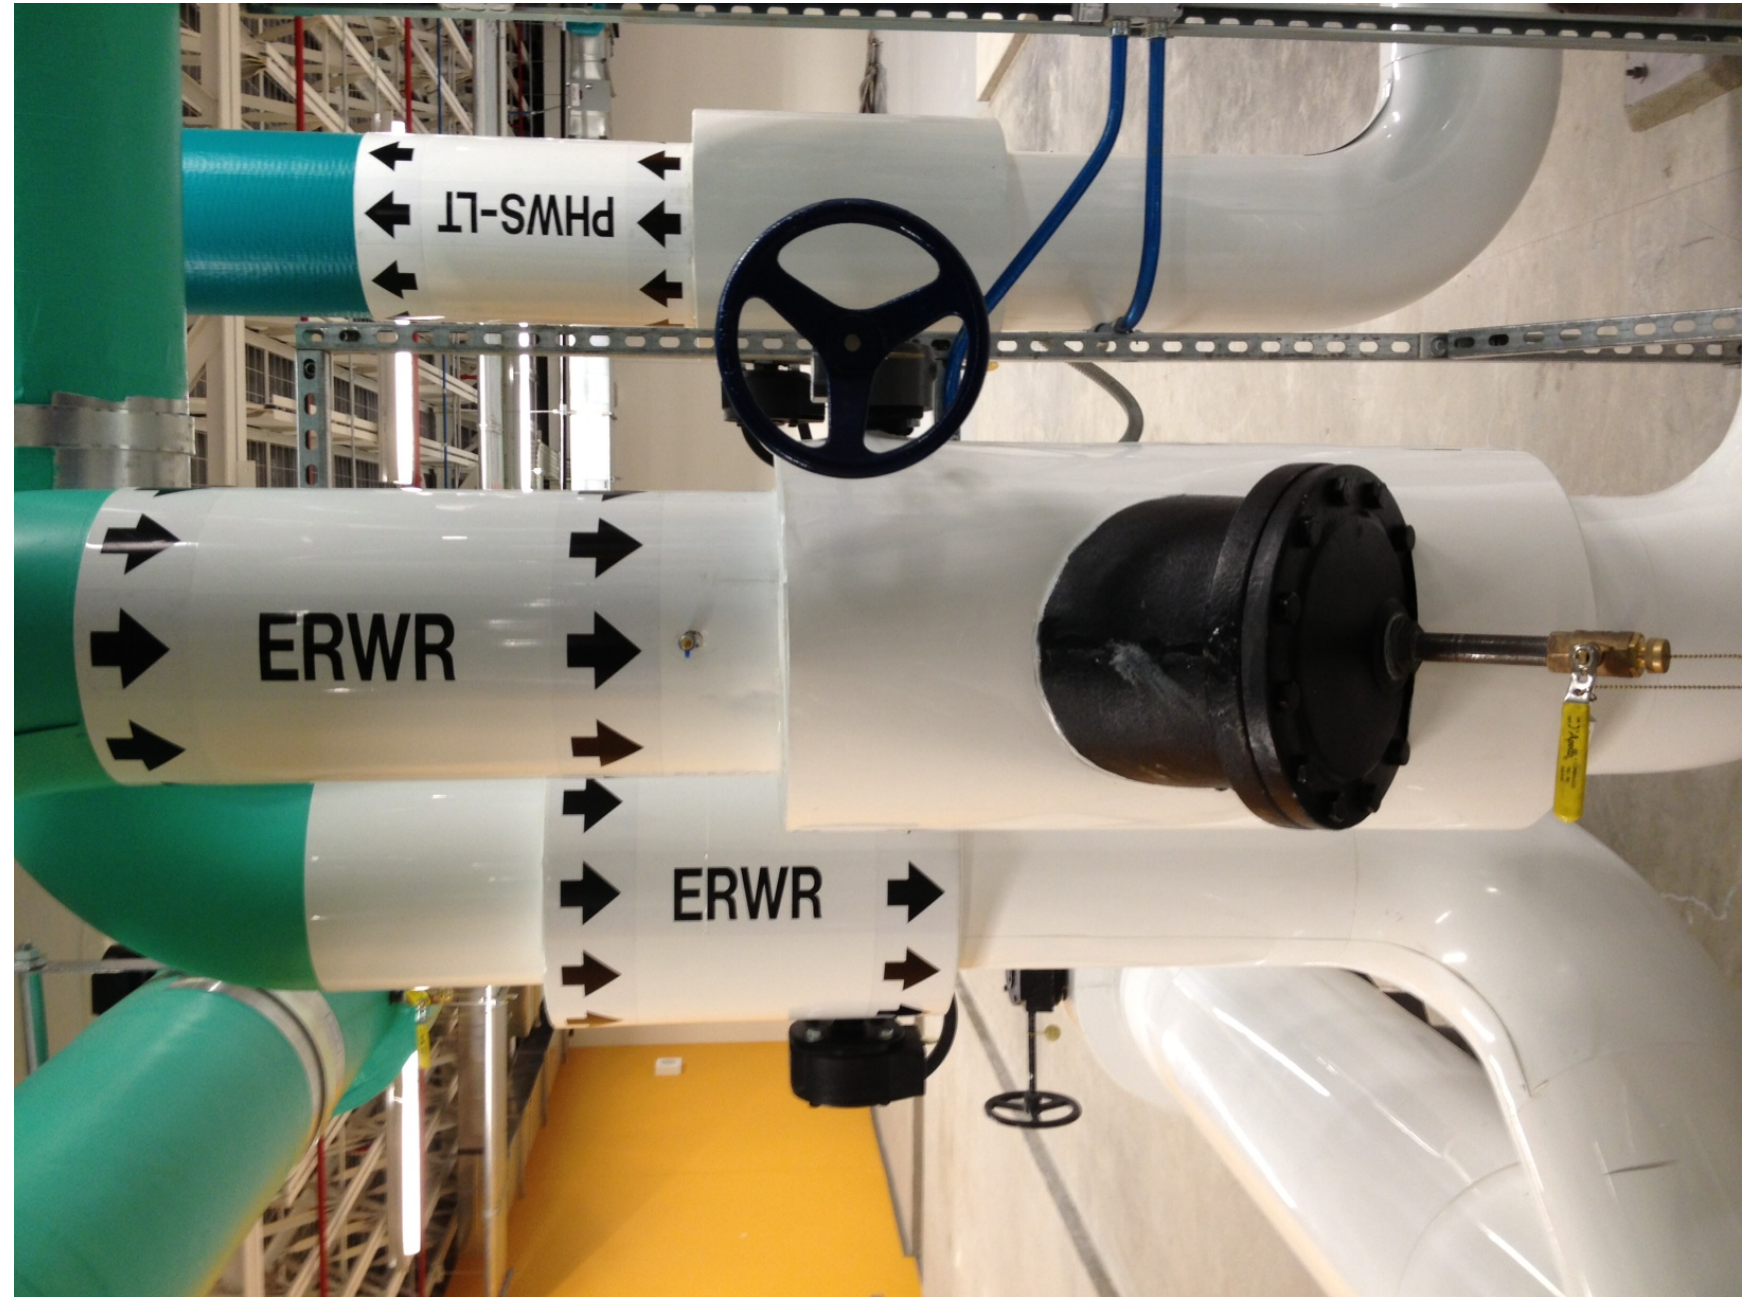
To determine root cause:

The first step was to blow down the strainer which did not show any sign of being fouled.

The second step was to remove the strainer and visually inspect. To do this we shut both valves upstream and downstream of the strainer and looked visually for traces of contamination. None was found.

The third step was to check pressure drop across the HX but could not get the proper flow to finish this step.

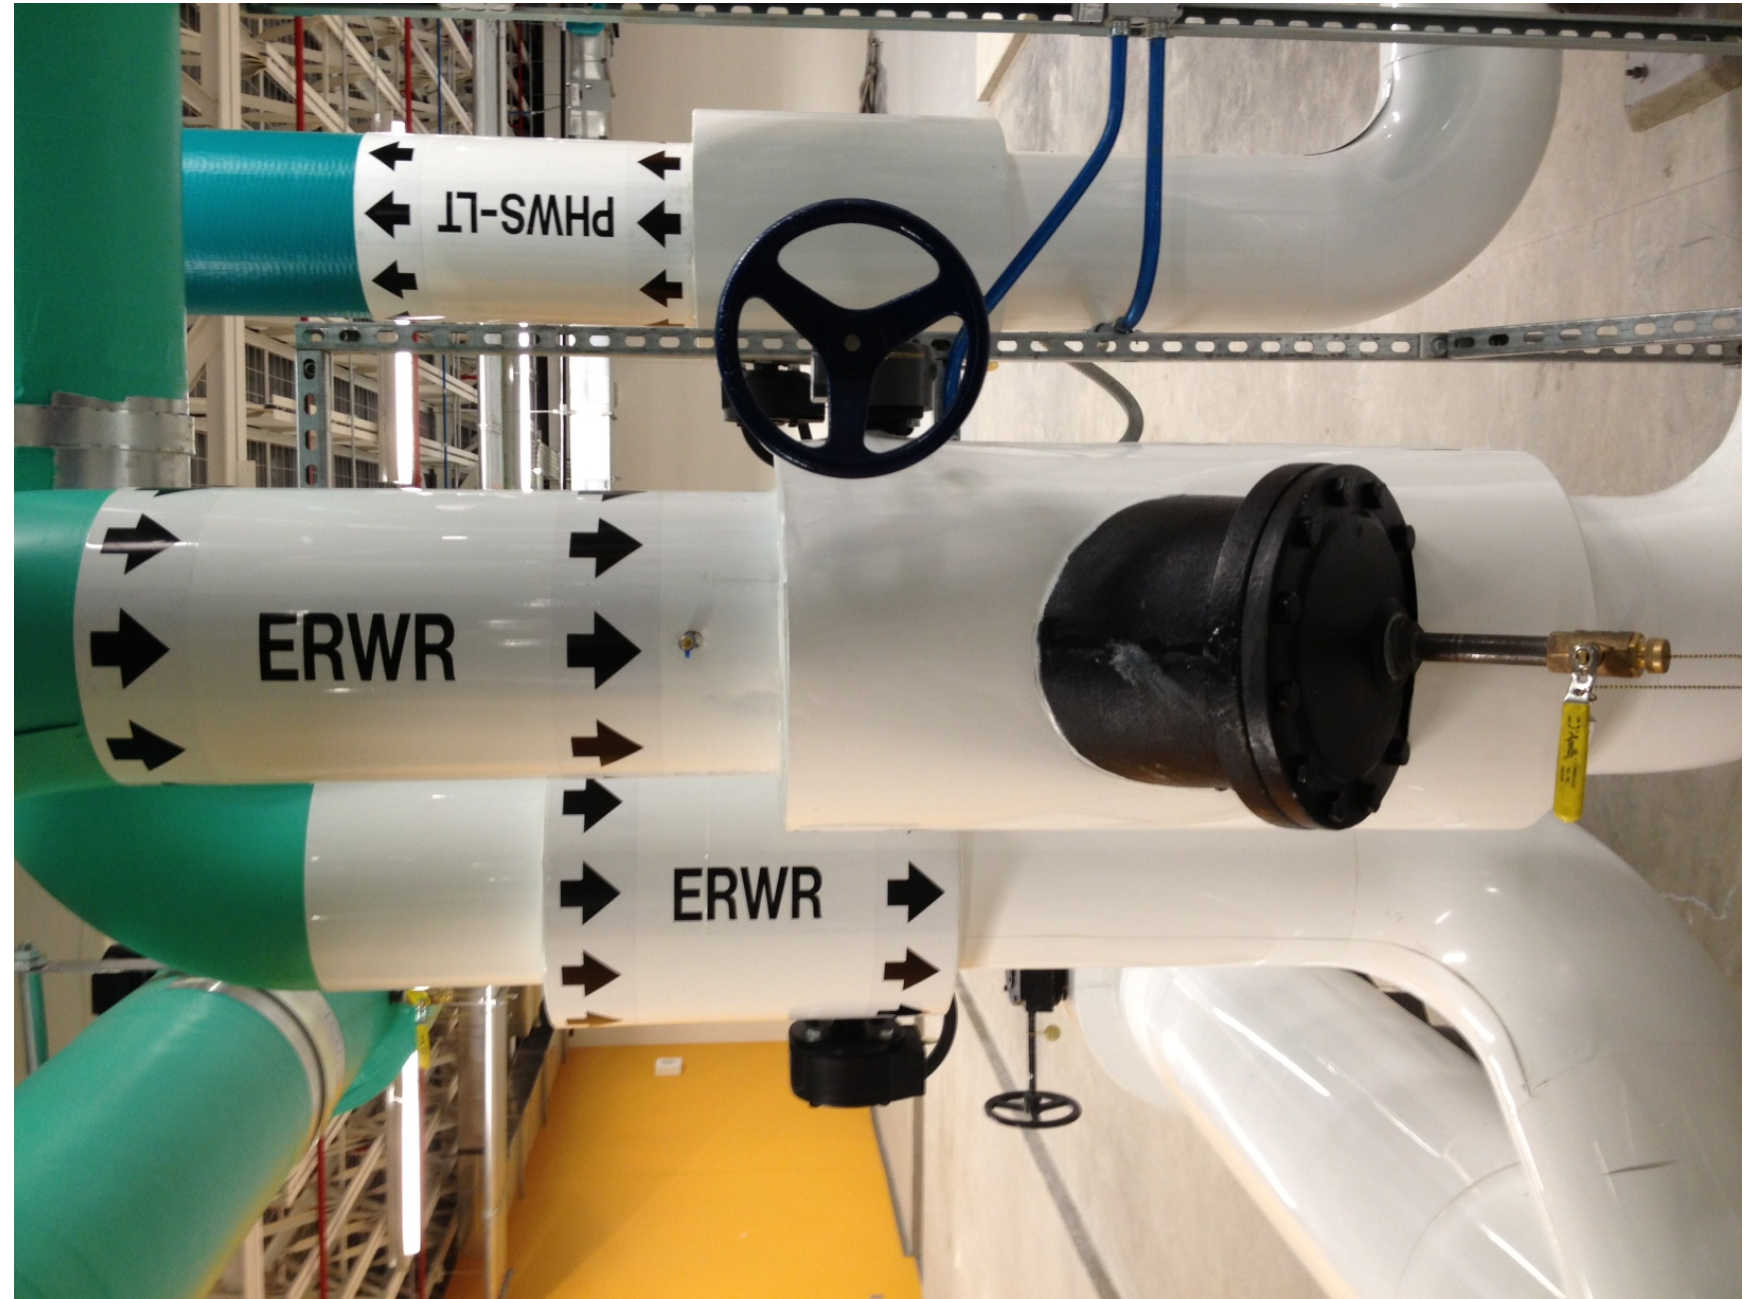
Check valve operations. The upstream valve operated correctly but when modulating we noticed free movement of the stem (i.e., not much resistance). Inspection showed the stem separated from the valve itself. This meant the valve appeared to be in the open position but was in fact closed to about 85%.

The pump system was shutdown and the valve upstream and downstream of the broken valve were closed and locked out. The system was drained via the strainer and the valve was replaced. The valve was then modulated to verify proper working condition.

Water flow and flushing test resumed with no further problems. Other than modulating all valves installed and looking for resistance there is no other test that can be performed to insure operation of manual valves.
